## Million Mile Teardown

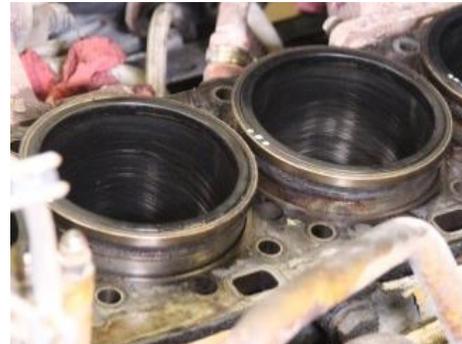
Low-quality diesel engine oils allow lacquer and sticky deposits to form in the honing grooves of the cylinder liner, resulting in a smooth, glazed liner surface finish. The glazed finish is caused by wear and deposit buildup and ultimately leads to a dramatic increase in oil consumption along with a decrease in torque and horsepower.

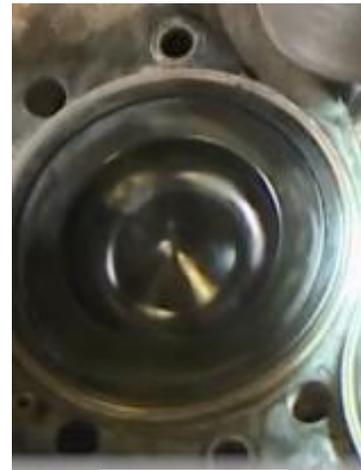
The teardown also gave us the opportunity to evaluate evidence left behind by fuel combustion in the combustion chambers. Dave's truck is used primarily for short hauls, providing opportunity to routinely fuel up with DieseleX Gold® additized diesel fuel.

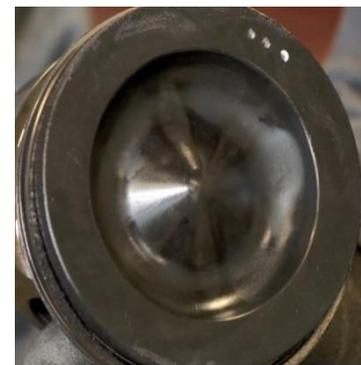
Figure One

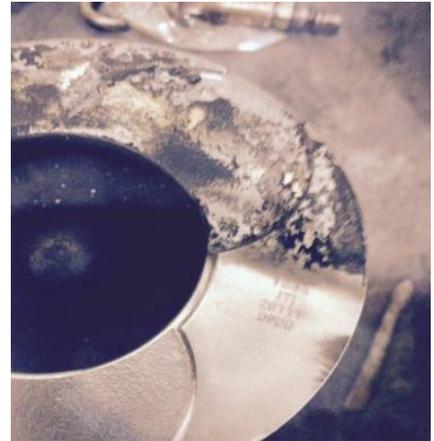
Figure Two
